The Journal of Bengal Geographer

Accelerated Geomorphic Hazard and Its Impact on Recent Coastal Environment: A Case Study at Jaldah To Mandarmoni Of Purba Medinipur (West Bengal)

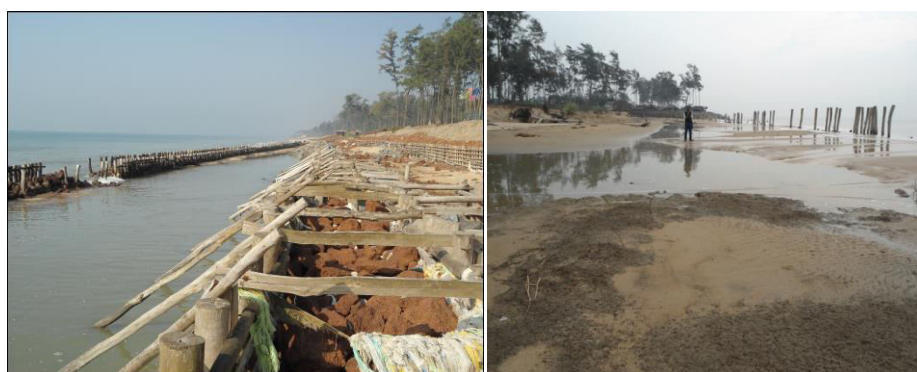
Photo No-1 : Narrowing beach width and exposed mud bottom along the chandpore coast

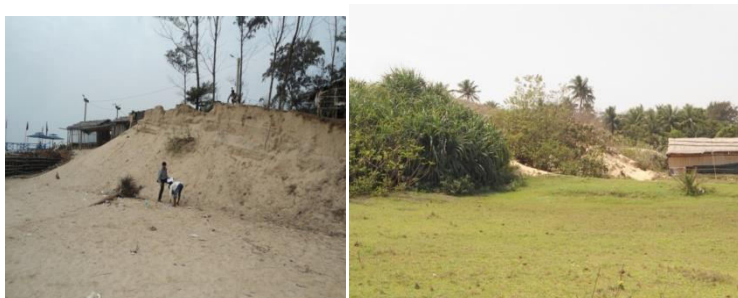
Photo No-2: Dune Erosion And Shifting Of Sand Dunes Of Chandpore-Jaldah Sector

The geological survey of India (1995) has detected that shoreline positioned 5-15km inland from the present shoreline around 6000years BP. Around 3000 years BP the shoreline position was 2-3km inland from the present shoreline .Further the public works, department constructed and inspection banglo, ½ of km inland from the place, with mouza Digha and Talgachari-I but with transgression of the sea this entire area has gone under the sea. Recently the Digha- Mandarmoni coastal area is landward shifting of shoreline due to local micro level rise of sae level and subsequent coastal erosion. Evidence also suggests that over the last 30 years the problems of erosion and shifting of shoreline have aggravated along this coastal tract (Table-6 and Photo-2, Fig No 3).

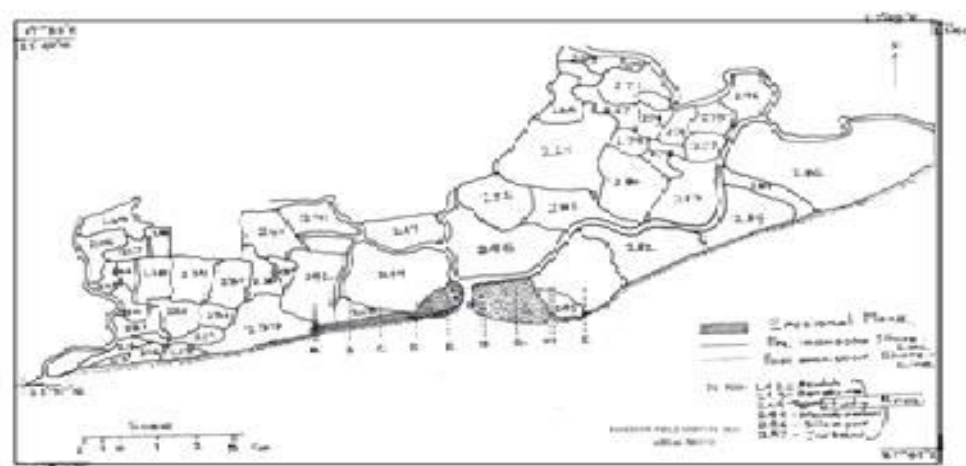
The rate of landward shifting of shoreline has been estimated by studying beach profiles and by interpretation of survey of India (SOI) toposheet, satellite images. From the recorded data and comparative study with survey of India toposheet, satellite images and field data it is found that during 1972-2014 the eastern part of this coastal tract from Digha estuary to Jaldah estuary about 13km was under prominent erosion and landward shifting of shoreline.

Fig-3: Beach profiles and seasonal shifting of shoreline .
